Seismic Retrofit of Gusset Plate Connections through Finite Element Analysis

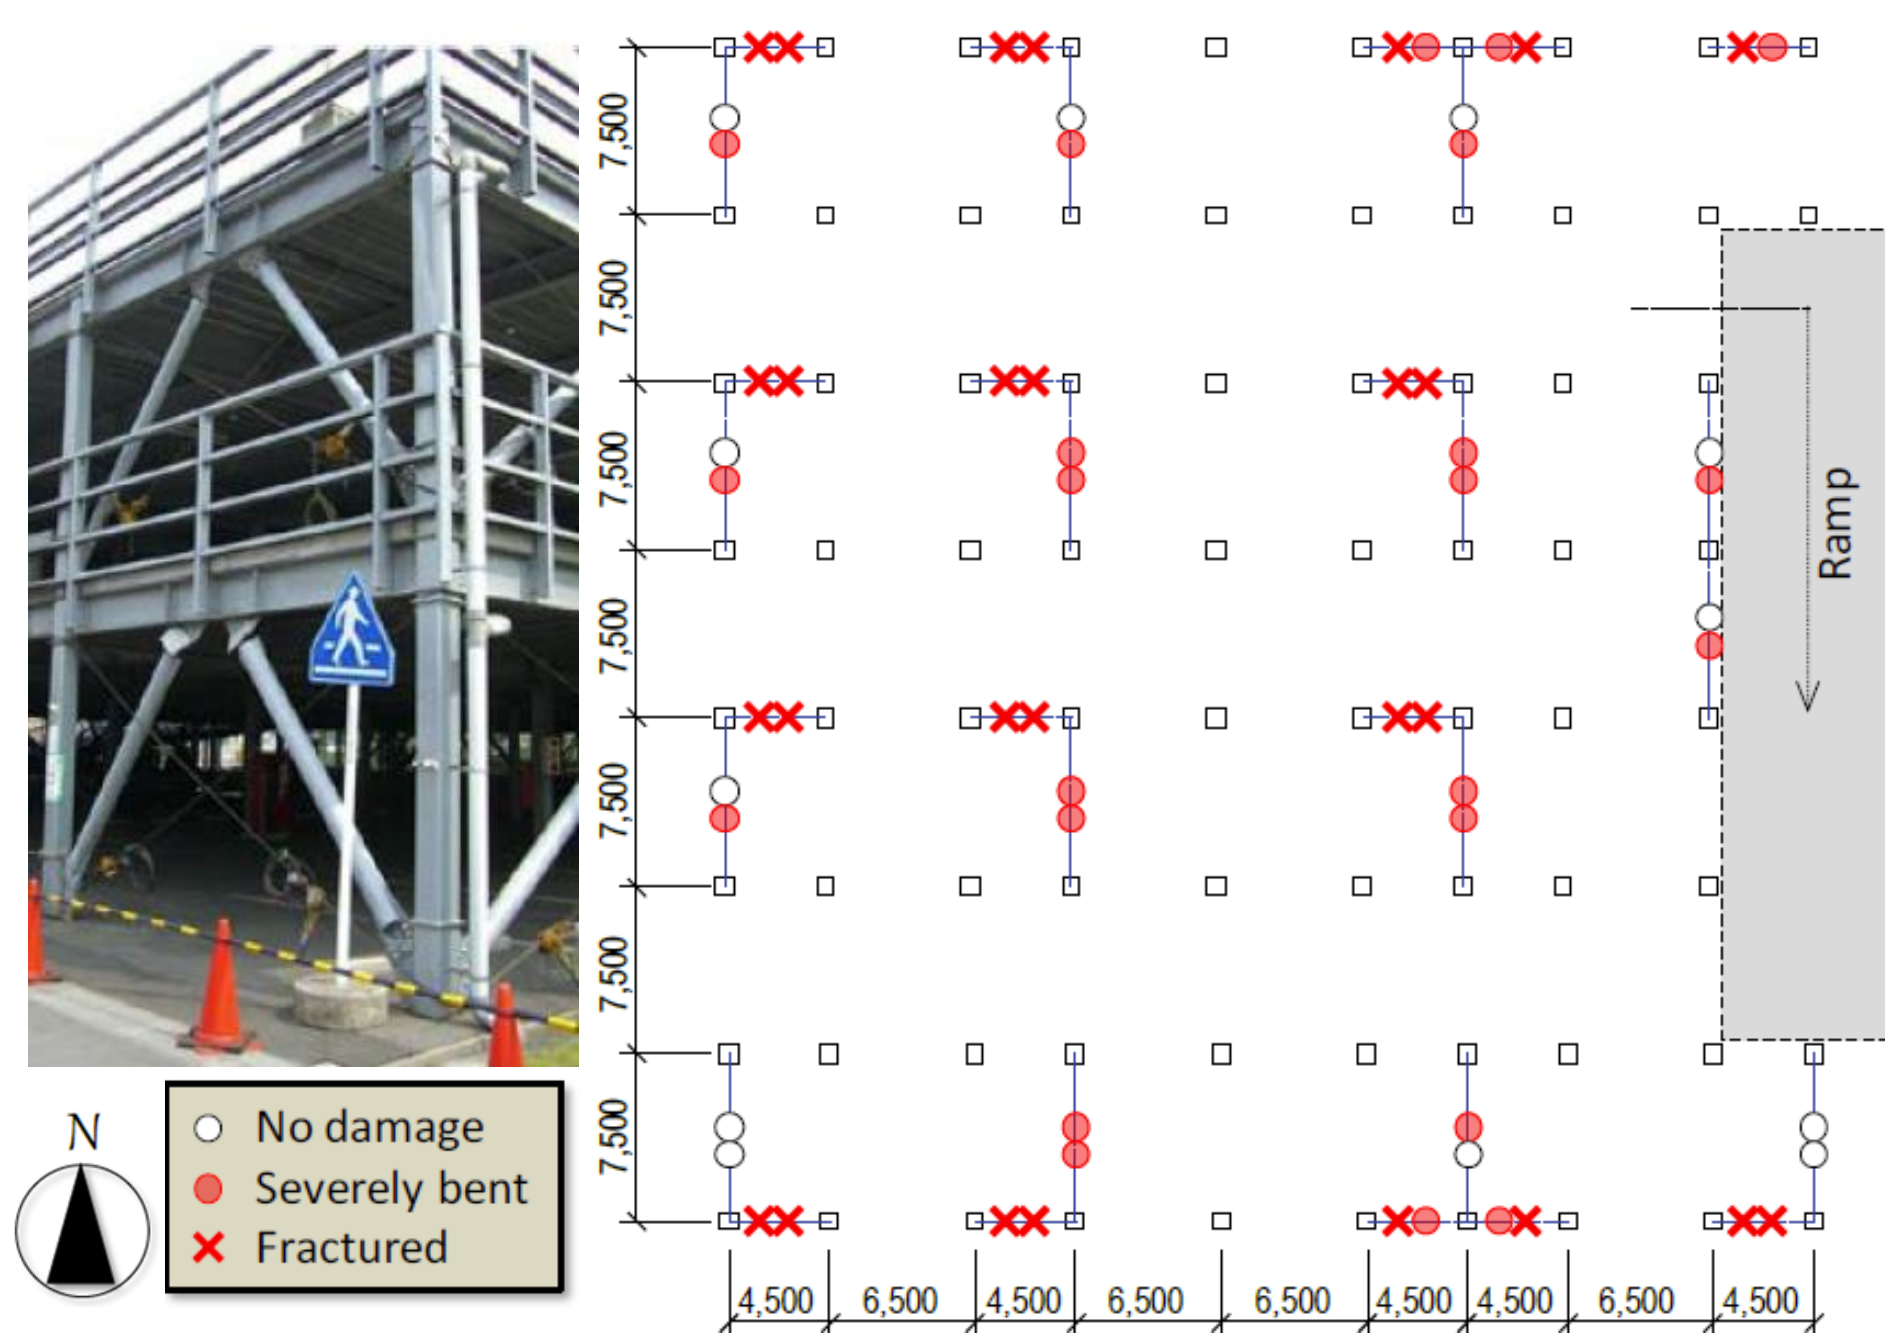
Fig 1. Damaged parking ramp and plan indicated damage location for the first story

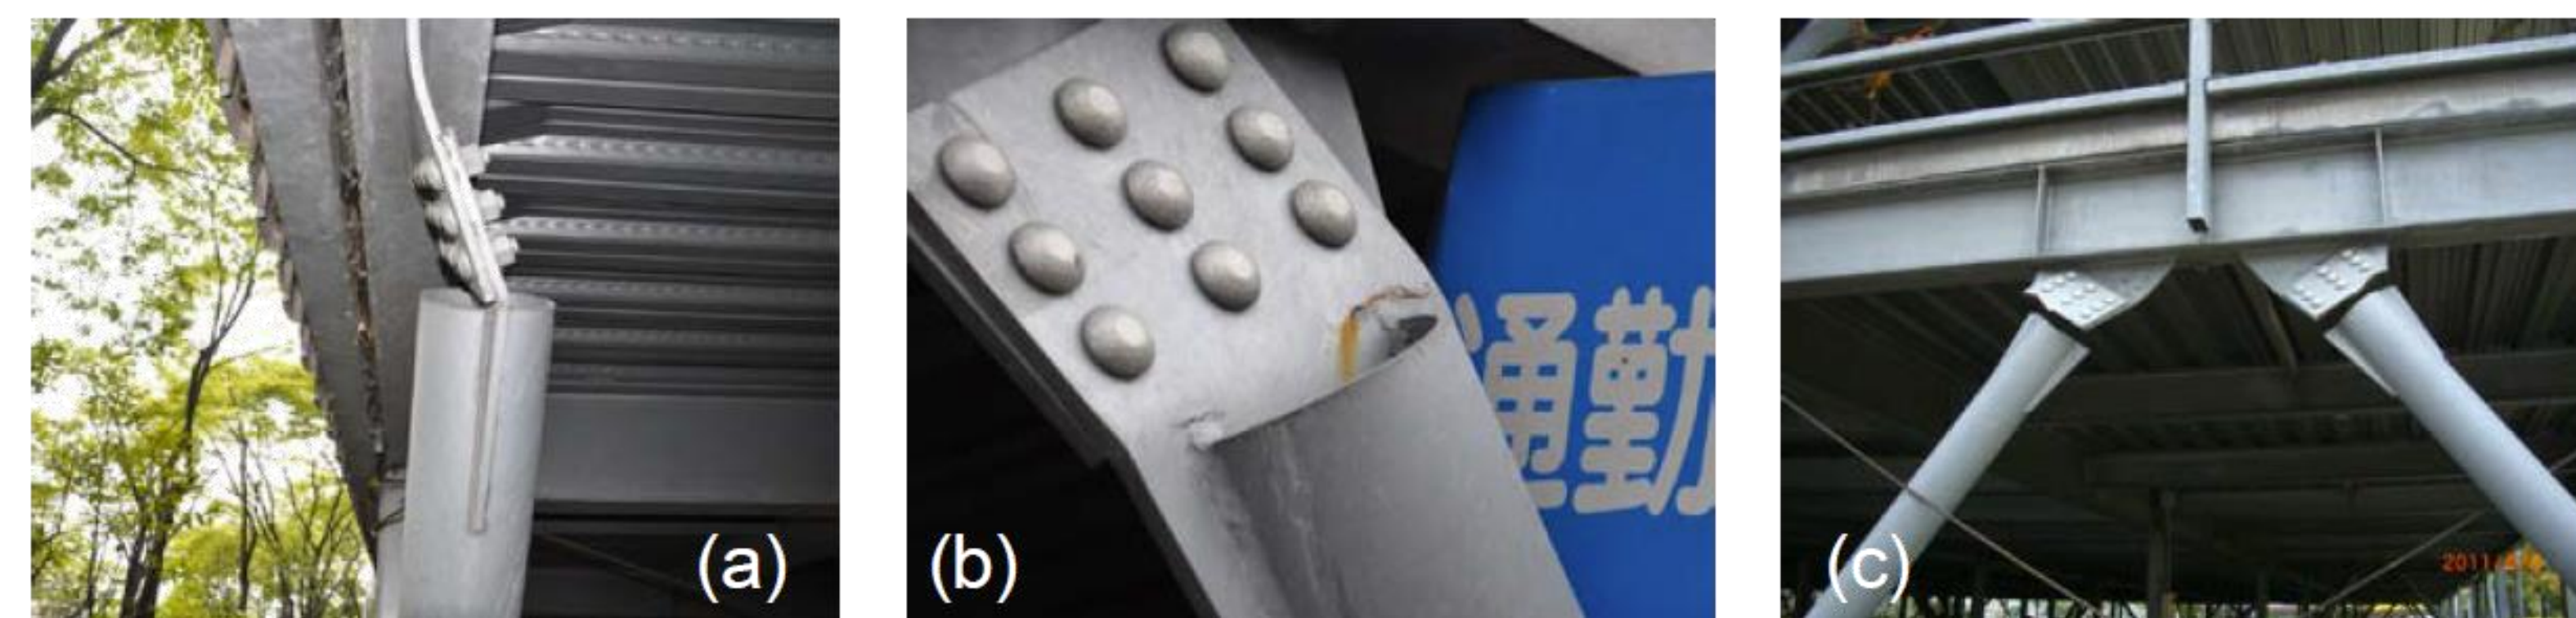
Fig 2. Connection damage: a) bent out of plane; b) fracture initiation; c) complete fracture

- The reason behind the failure is the concentration of inelastic deformation in the gusset plate forming a double hinging mechanism when the brace was in compression because of the eccentricity in the gusset plate connections.
- Several retrofit concepts have been simulated and each of them observed a considerable increase both in strength and in deformation ductility.
- Retrofit n°4 proved to be the best alternative as it presented superior pre- and post-failure behavior.

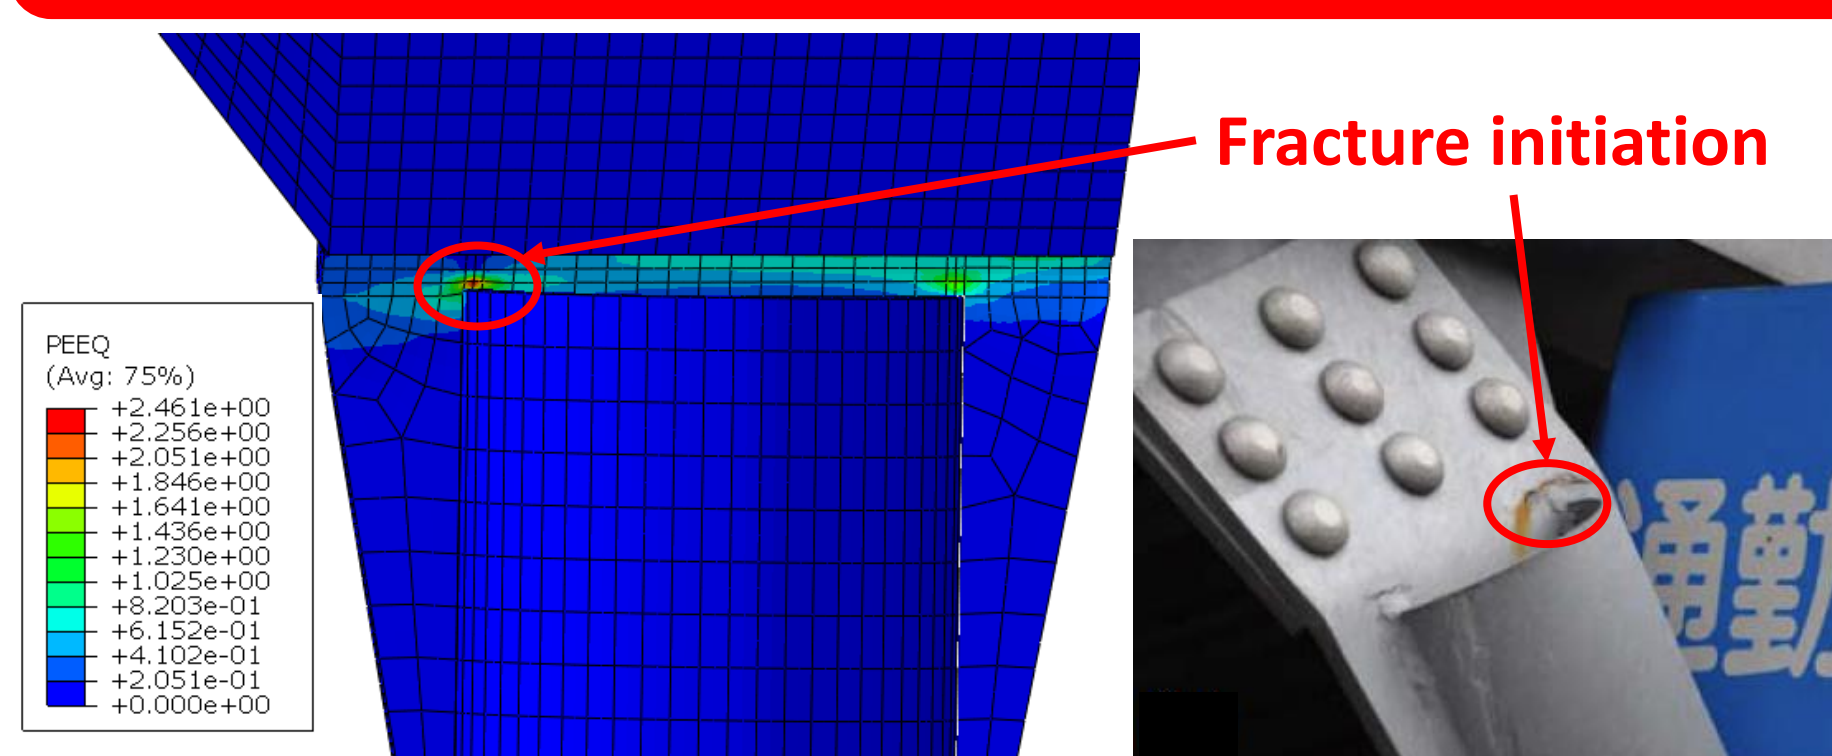
Fig 4. Location of the fracture initiation

- Fracture analysis has been assessed with the Cyclic Void Growth Model (CVGM).
- The CVGM represents ductile fracture mechanism through plastic strain and stress triaxiality histories.
- The model states that fracture is supposed to occur when the Void Growth Index (VGI) exceeds a specific critical value treated as a material property.
- The analysis shows that fracture should occur at approximately 0.6% story drift ratio.

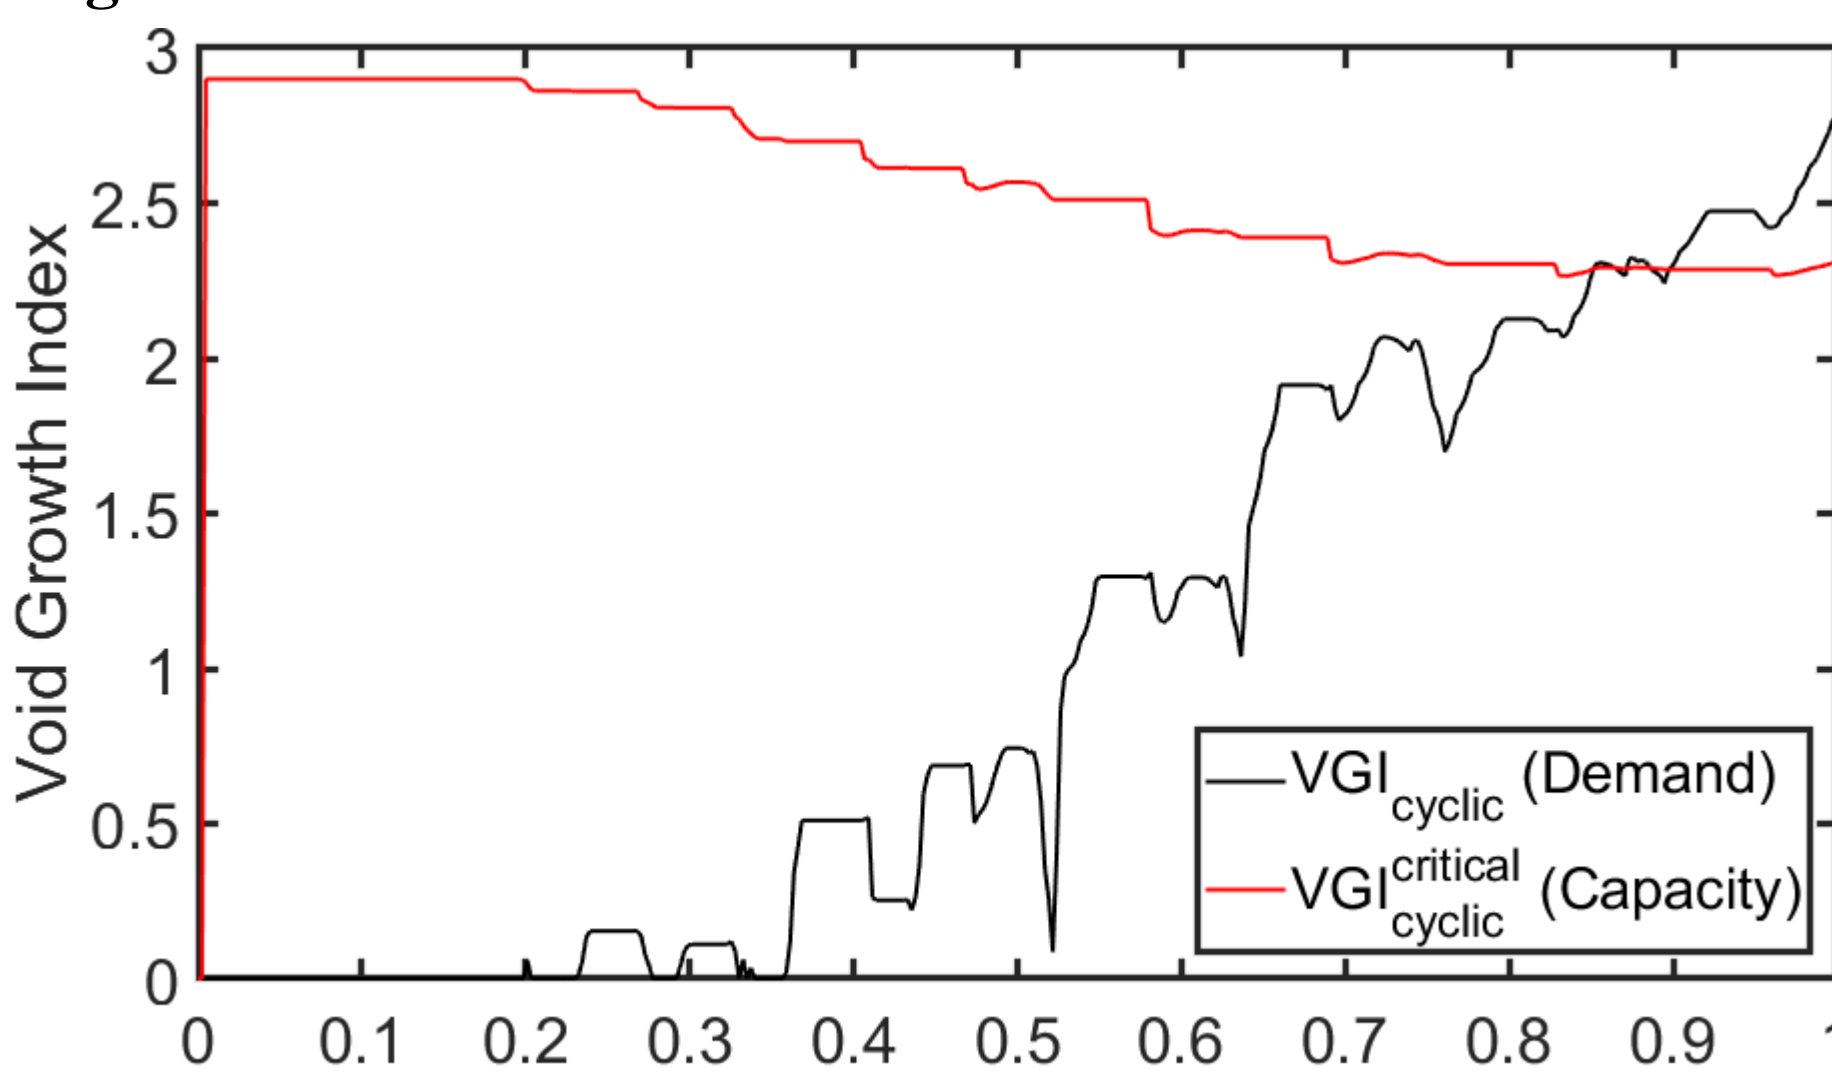
Fig 5. Void Growth Index

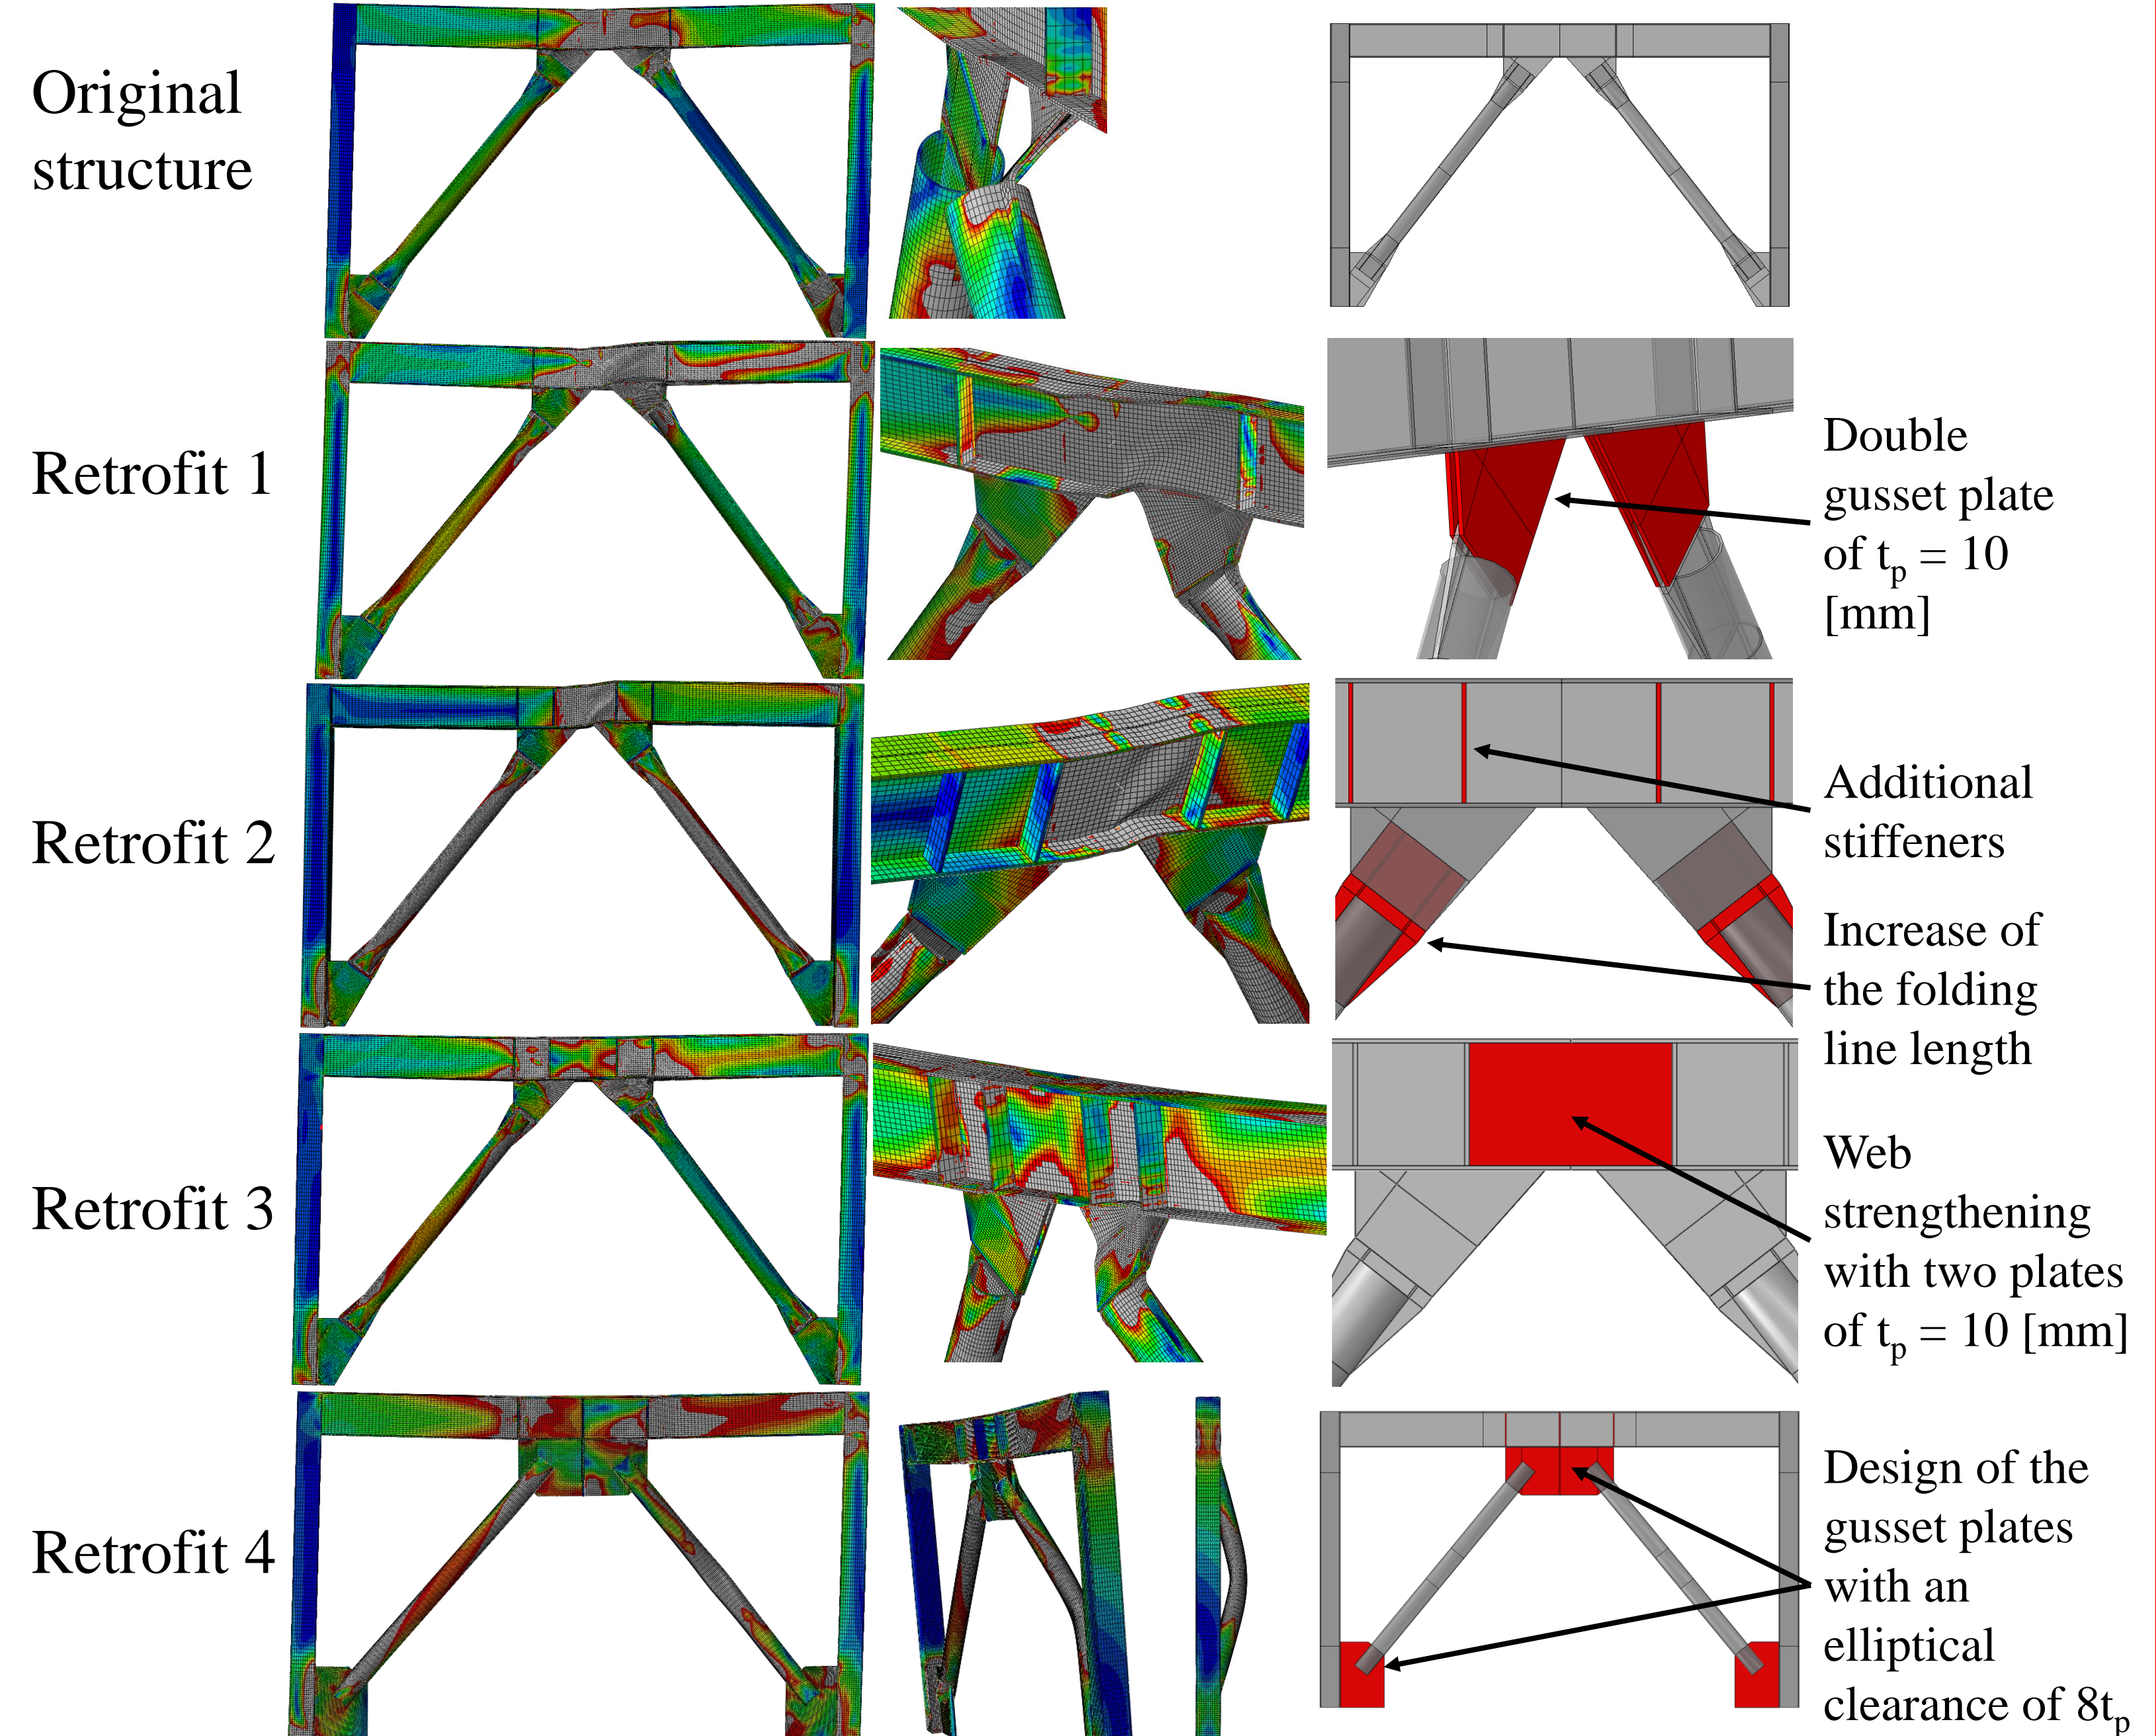
Fig 6. Failure mechanisms of original and retrofit structures and retrofitted parts drawn in red

Model	Failure mechanism	Story shear force at failure [kN]	Story drift ratio at failure
Original structure	Double hinging mechanism of the brace connections	325 [kN]	0.14%
Retrofit 1	Shear failure of the beam web followed by double hinging mechanism	825 [kN]	1.37%
Retrofit 2	Shear failure of the beam web followed by double hinging mechanism	884 [kN]	1.75%
Retrofit 3	Over-stiffened beam web and insufficient rotation capacity of the gusset plate led to double-hinging mechanism	869 [kN]	0.42%
Retrofit 4	Buckling of the brace in compression	946 [kN]	0.96%
