Fatigue Study of the Linthkanal-Brücke

Auteure : COPIGNEAUX Louise

<sup>1</sup> Resilient Steel Structures Laboratory (RESSLAB) EPFL

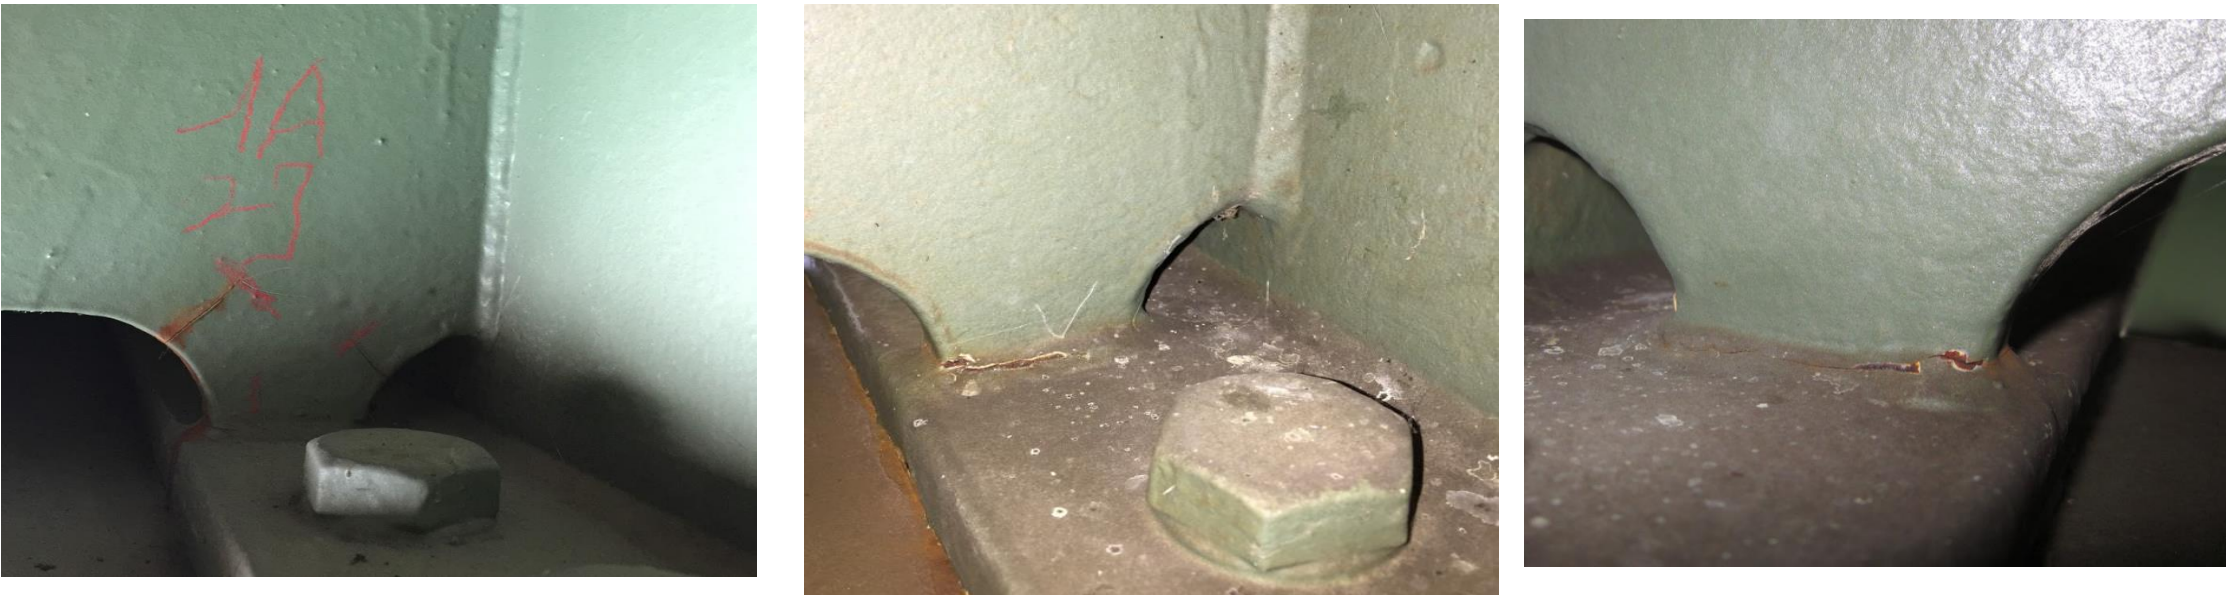
The damages occurring under the passing of one train were calculated using the hot-spot method, and every details at risk were compared. Ultimately, the lower welds of the transversal stiffeners were discovered to be the most likely to fail under fatigue.

Figure 7: Damages pictures

The results showed that, while the hangers of the bridge are not at risk of fatigue failure, the cracks in the critical details of the transversal stiffeners on top of the crossbeams are explainable. Indeed, the very rigid connection between the crossbeam and the bridge main span deck creates a mixed system behaviour, very similar to an orthotropic deck. This outcome was supported by the existing crack locations found in the bridge. This understanding back-up the recommendation of loosening the bolts connecting the crossbeams and the deck stiffeners elements. Hence this action would result in reducing the connection between the aforementioned elements and relieve the details under strong fatigue loads.
