Seismic Retrofit of Gusset Plate Connections through Finite Element Analysis

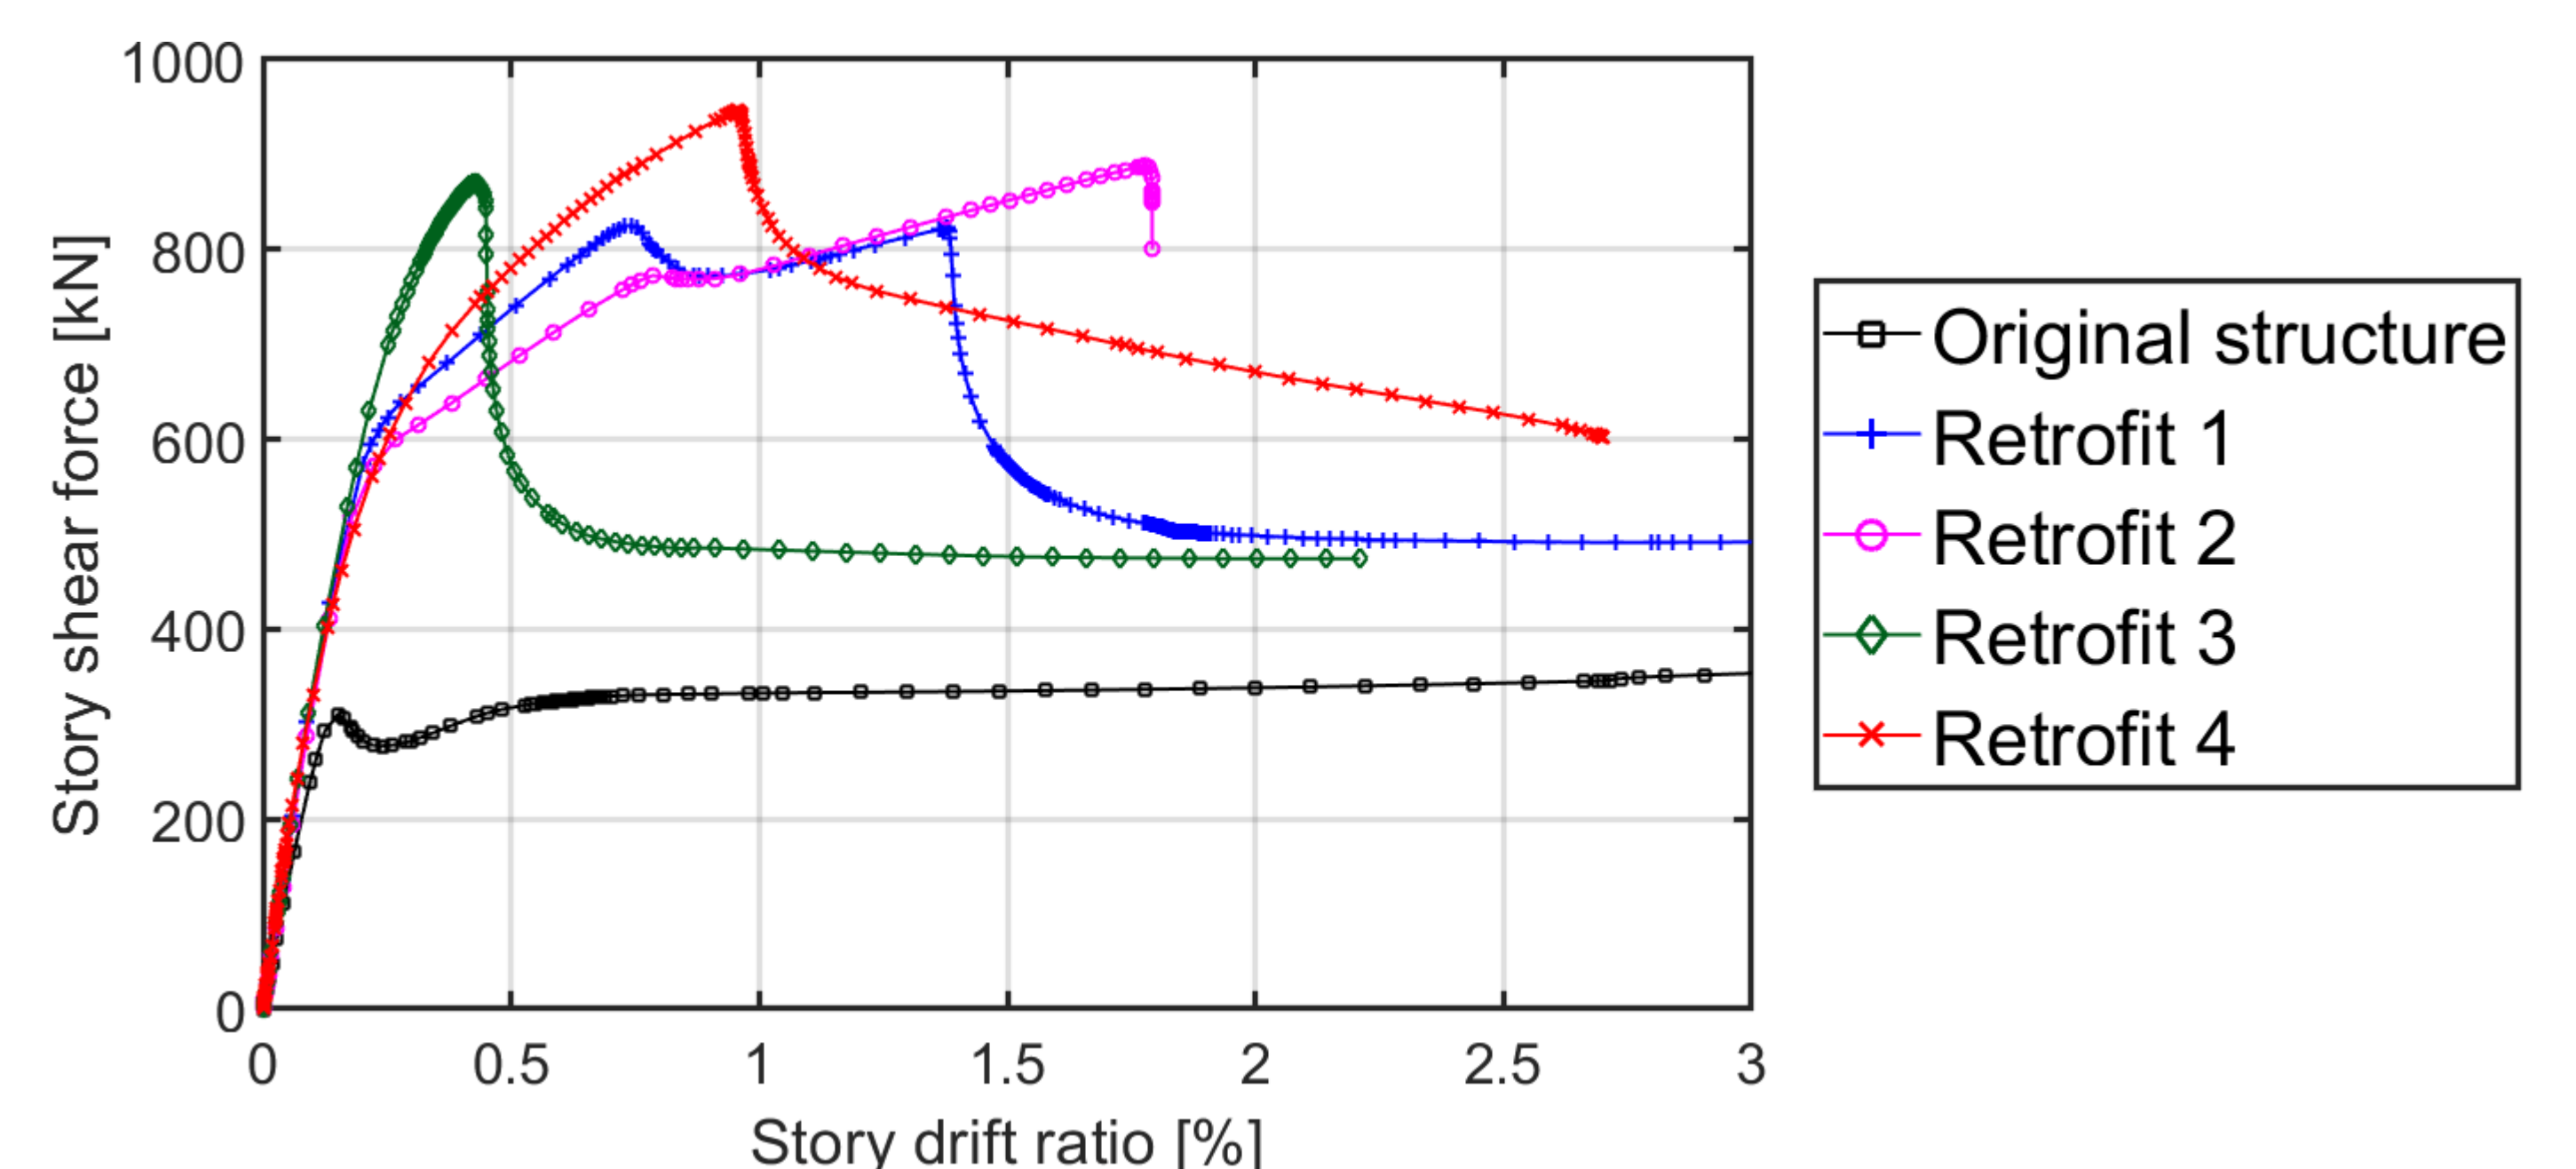
Model	Failure mechanism	Story shear force at failure [kN]	Story drift ratio at failure
Original structure	Double hinging mechanism of the brace connections	325 [kN]	0.14%
Retrofit 1	Shear failure of the beam web followed by double hinging mechanism	825 [kN]	1.37%
Retrofit 2	Shear failure of the beam web followed by double hinging mechanism	884 [kN]	1.75%
Retrofit 3	Over-stiffened beam web and insufficient rotation capacity of the gusset plate led to double-hinging mechanism	869 [kN]	0.42%
Retrofit 4	Buckling of the brace in compression	946 [kN]	0.96%

Fig 7. Static pushover analysis responses

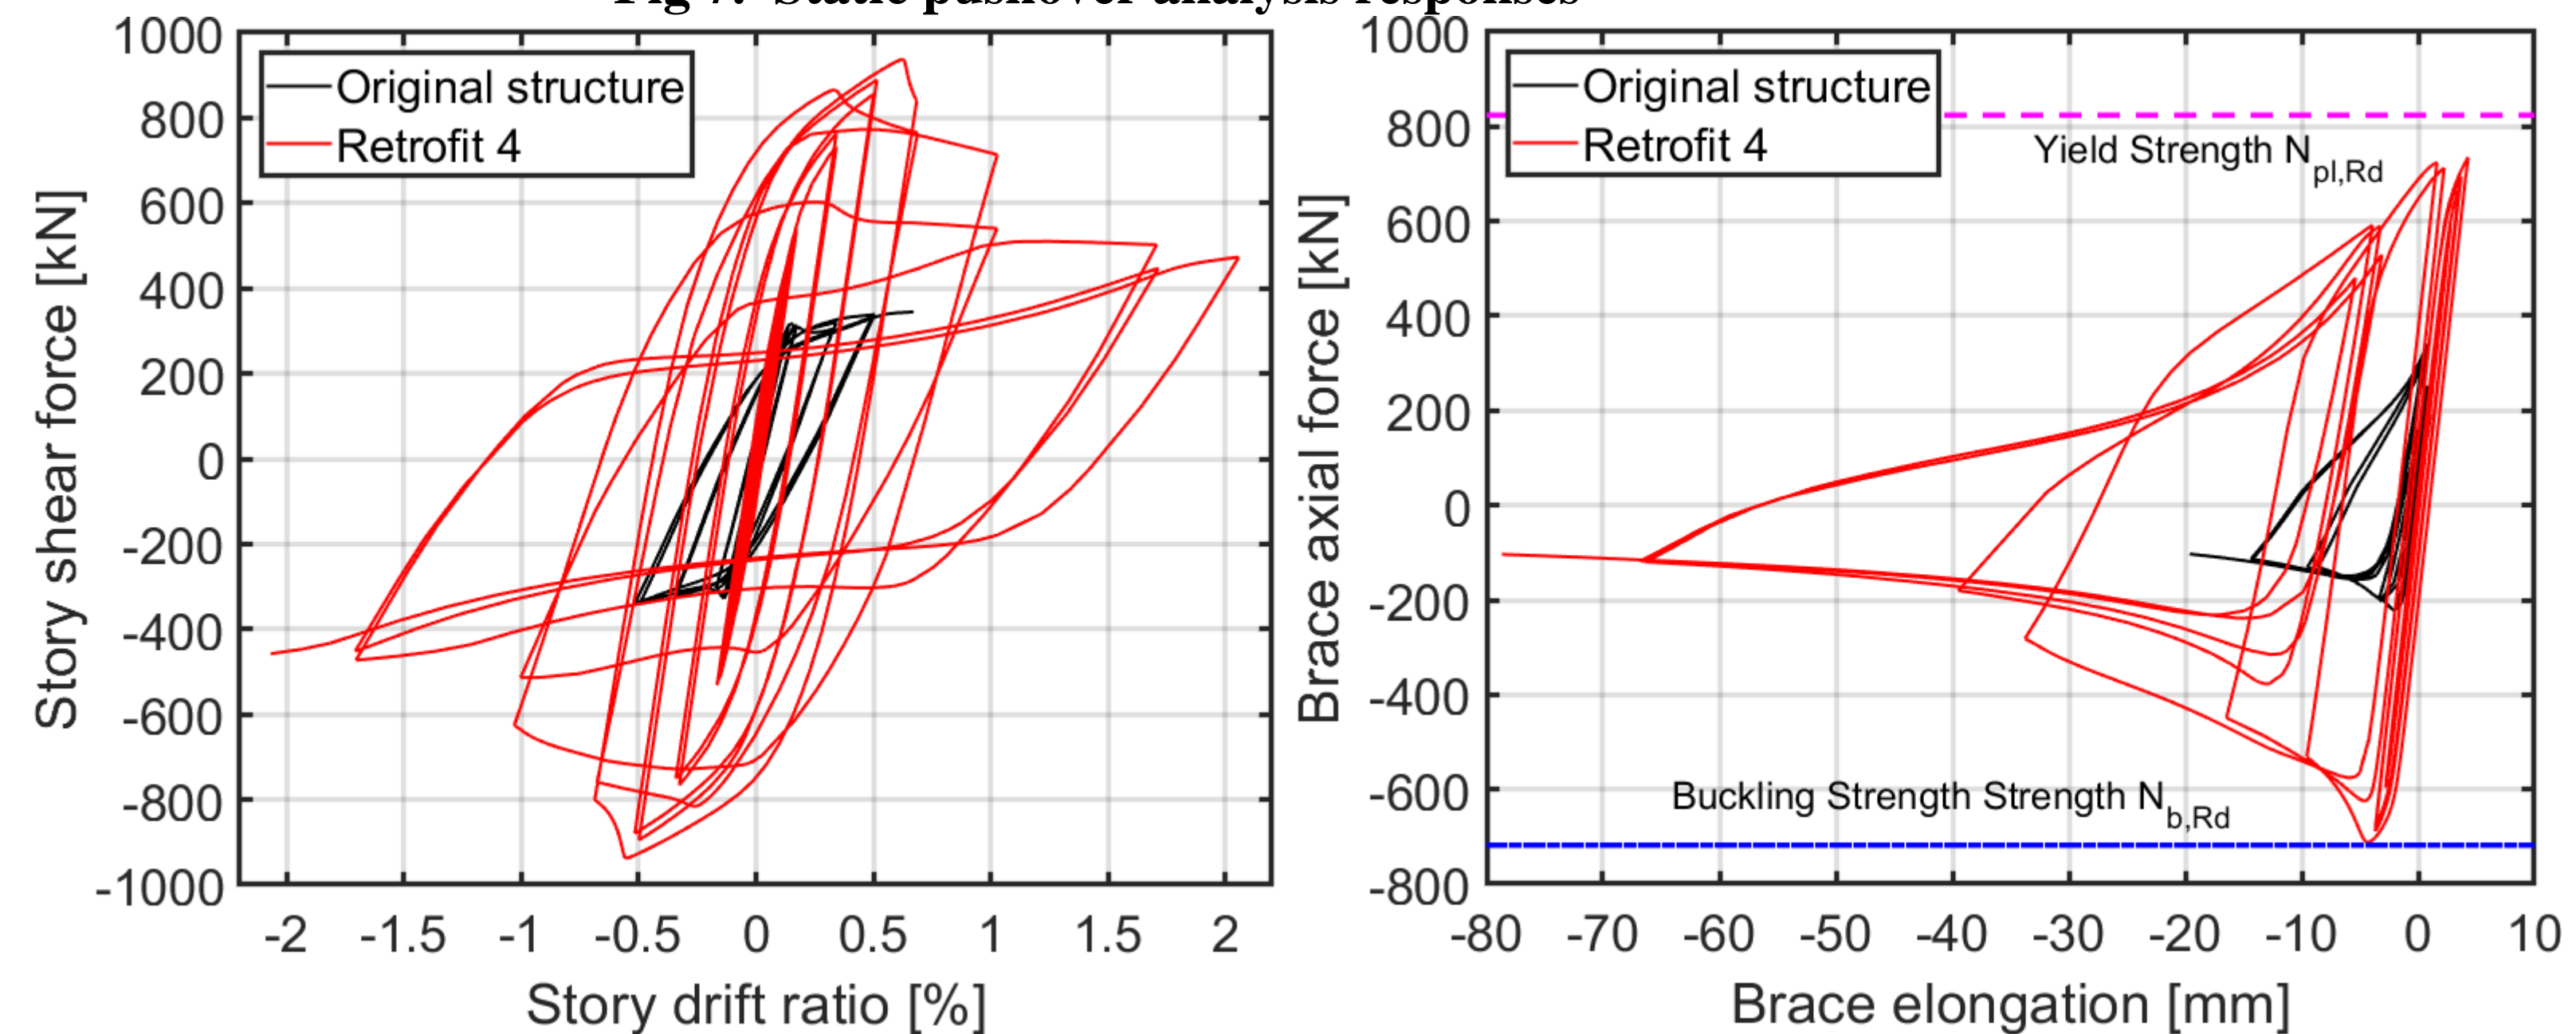
Fig 8. Cyclic Loading Response

Fig 9. Hysteresis of brace
